Product Parts of Copper alloy

Part Name	Thermostat
Part weight	80g
Copper Alloy Component weight	10g
Content % of Lead	1.8-3.7

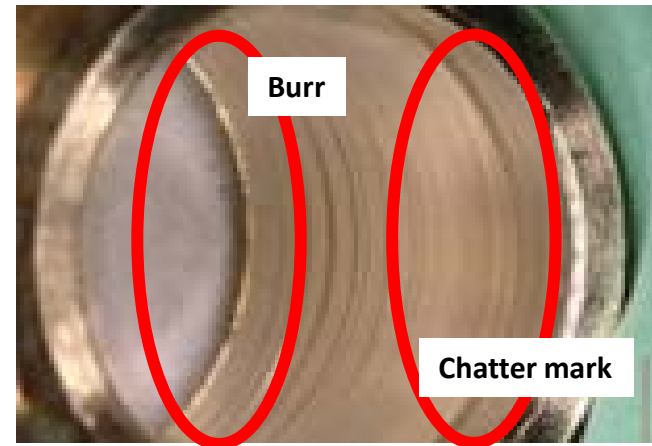
Photo: Pb2.2%

After cutting only 400 sample pieces the Pb2.2% sample exhibited a rough surface with grooves in the radial direction and a continuous burr on the edge.

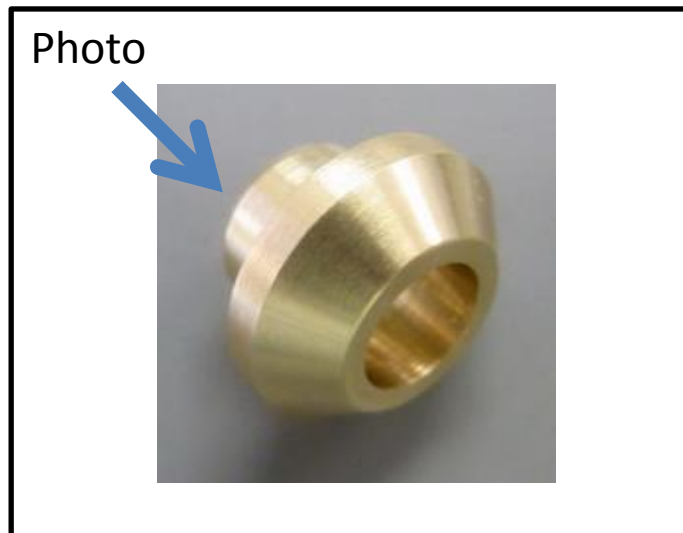
Photo: Pb3.07%

The surface of the Pb3.07% sample was smooth.

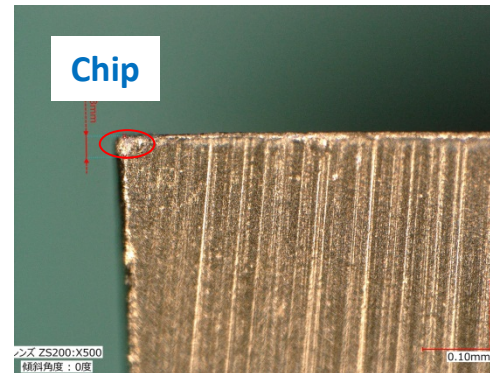
Photo: Tool Pb2.2% (430pcs.)

At some point during the Pb2.2%, 430 piece test, the cutting tool edge became chipped. No damage to the cutting tool tip was observed on the 3.07% Pb cutting tip until 25,000 pieces.
