innovative engineering quality testing global thinking	<i>TEST REPORT</i>	
	Test ID #: 25112 PO#: 11500 Date: 11/19/09	Page 1 of 2

**Test Items:** *Backlite*  
**Rec. Date:** *11/9/09*  
**Qty.:** *1 unit*  
**Condition on Receipt:** *No visual anomalies noted.*

**Test Summary:** *Temperature Measurements*

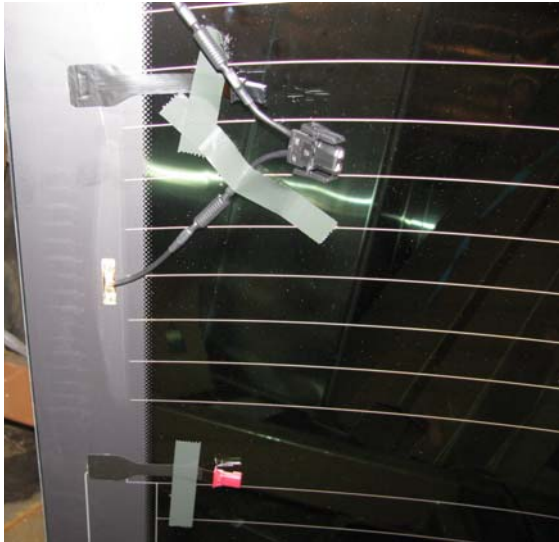
Left Side

*The test was run per the Customer's instructions. The windshield was placed in a walk-in chamber with thermocouples placed on the Center, Right Bus Bar, Left Bus Bar, Left Top Ground, Left Bottom Ground, Right Top Power and Right Bottom Power. The thermocouples were monitored throughout the testing. The test was started at 20°C the windshield was powered at 14 volts for 30 minutes off for 5 minutes and then back on for an additional 30 minutes. During the powered up portion of the test, pictures of the windshield were taken with an IR Camera. This same procedure was repeated for 30°C, 40°C, 50°C, 60°C, 70°C and 80°C. All of the data and pictures were emailed to the customer. The windshield was returned to the customer on completion of testing.*

**Test Results:** *All of the data and pictures were emailed to the customer. See attached photographs of sample mounting.*

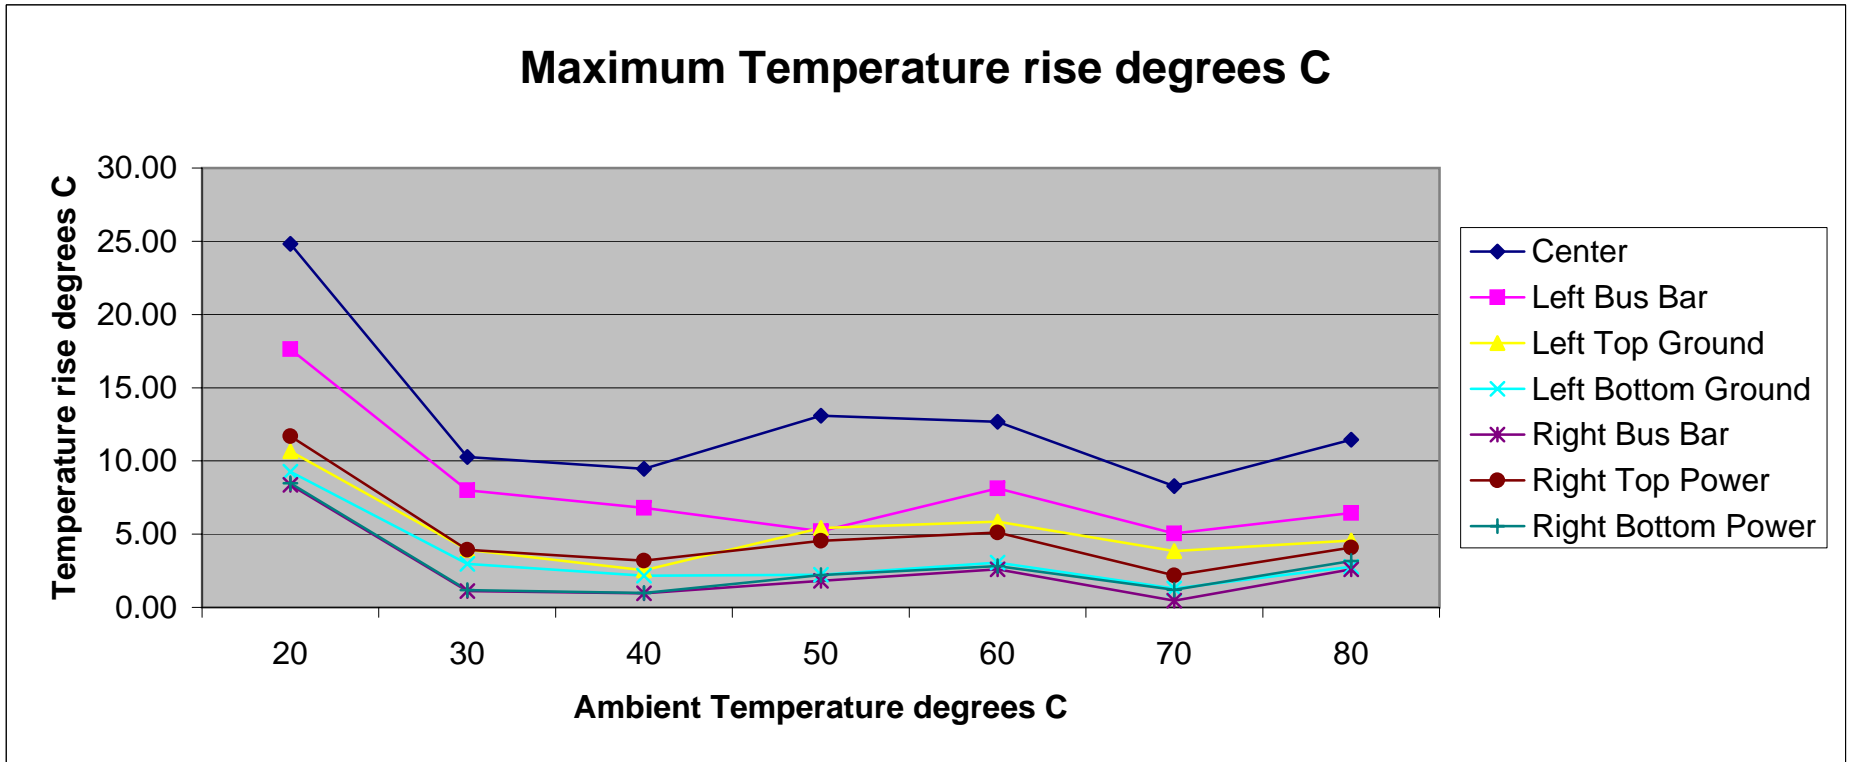
Maximum recorded temperature rise C°

Ambient Temperature C°	Center	Left Bus Bar	Left Top Ground	Left Bottom Ground	Right Bus Bar	Right Top Power	Right Bottom Power
20	24.83	17.63	10.67	9.27	8.37	11.68	8.48
30	10.27	8.00	3.94	2.98	1.10	3.92	1.19
40	9.46	6.79	2.53	2.16	0.95	3.18	0.99
50	13.08	5.19	5.41	2.24	1.81	4.54	2.20
60	12.67	8.14	5.85	3.05	2.59	5.10	2.82
70	8.28	5.05	3.85	1.30	0.46	2.19	1.20
80	11.46	6.45	4.56	2.77	2.59	4.08	3.17

- 1 Thermocouples were attached to the solder pads of the connectors marked "Ground" and "Power".
- 2 Thermocouples were attached to the bus bars and the center of the heating grid.
- 3 The tests were run for 30 minutes plus the time needed to stabilize the ambient temperature.
- 4 The heated grid was powered up with 14VDC for approximately 30 minutes

- 1 The center grid is always hotter than the bus bars or the connectors.
- 2 The temperature rise is significantly greater when the ambient temperature is in the lowest range.
- 3 The highest absolute temperature on the connectors was less than 85C°
