# Test Report

High Temperature Monitoring Test  
for Automotive Backlites

06.08. - 30.08.2010 in Seville, Spain

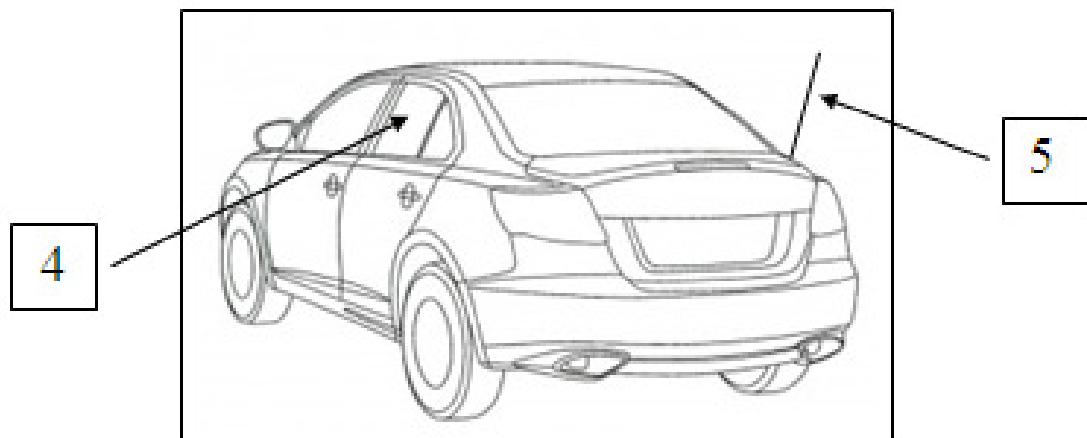
**Figure 1: Sensor positions 1**

1. Passenger side heatgrid terminal
2. Center of glass
3. Driver side heatgrid terminal
4. Ambient temperature inside vehicle (backseat)
5. Ambient temperature outside vehicle (feed through hatch)

Figure 1 shows the positioning of the sensors.

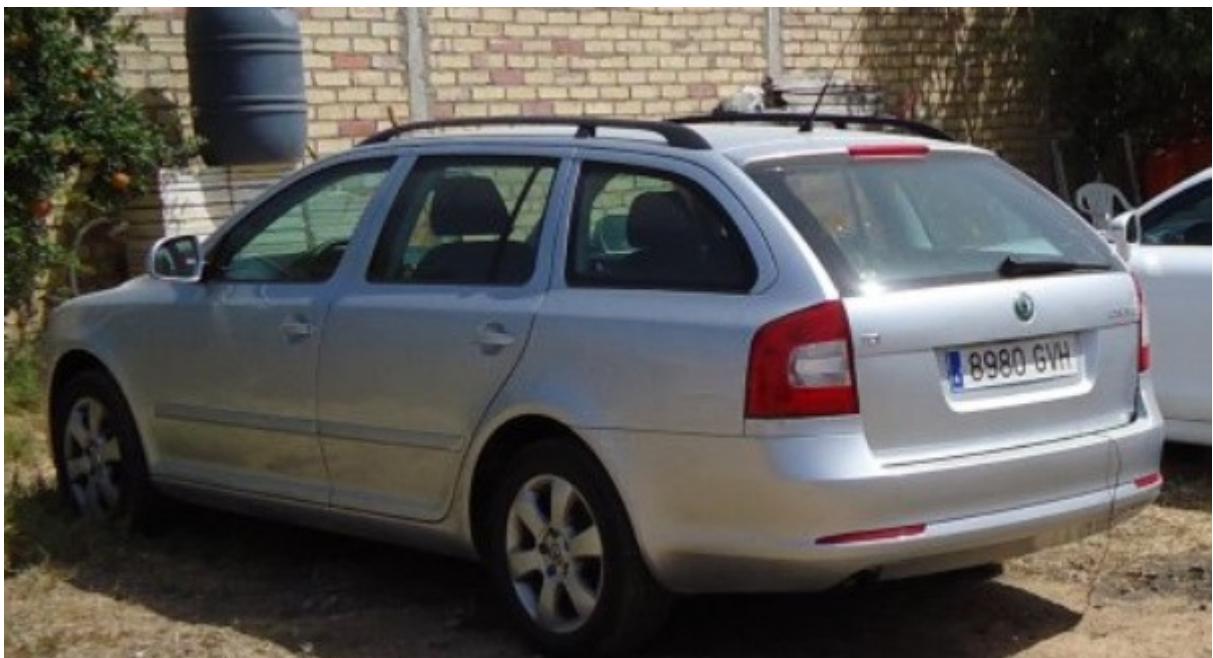
Figure 6: Skoda Octavia wagon

Skoda Octavia wagon

Year of manufacture: 2000

Angle backlight: 55° to vertical

Light transmission: Green Glass

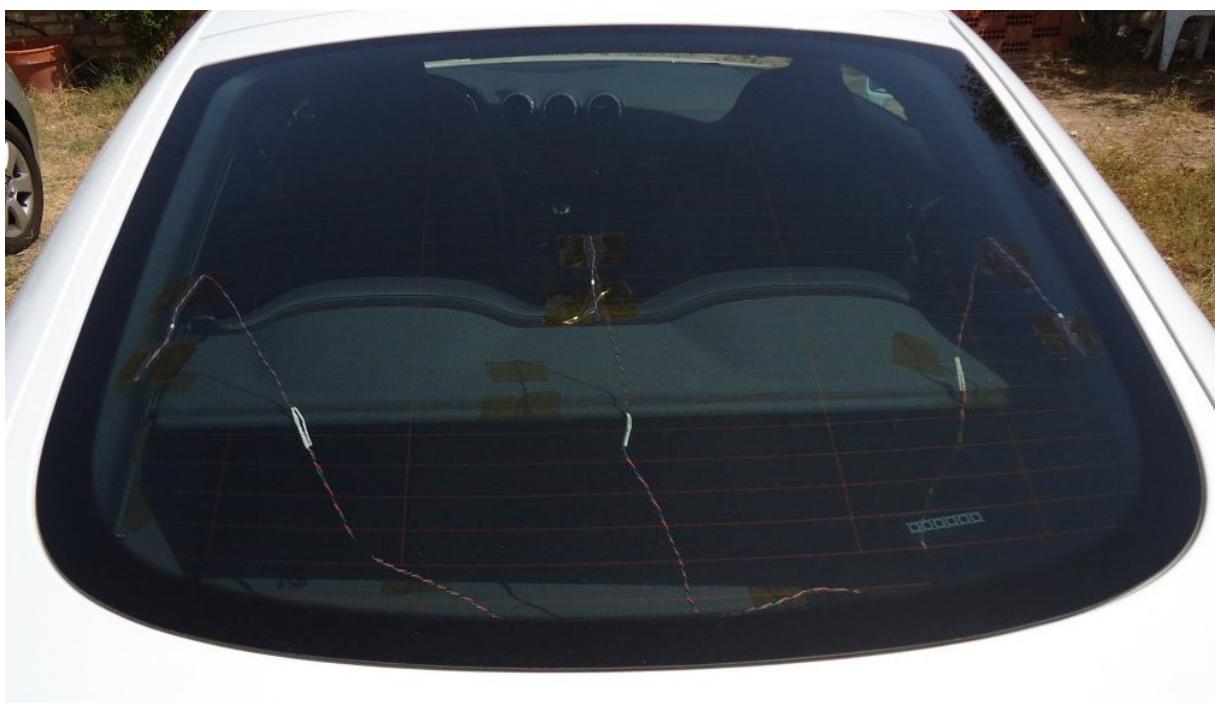
Figure 11: Audi TT Coupé - Sensor positioning

In the following chapter all tested cars are listed including information about year of manufacture and details about the backlite. The sensors at the backlite are taped with Kapton polyimide to keep them in position.

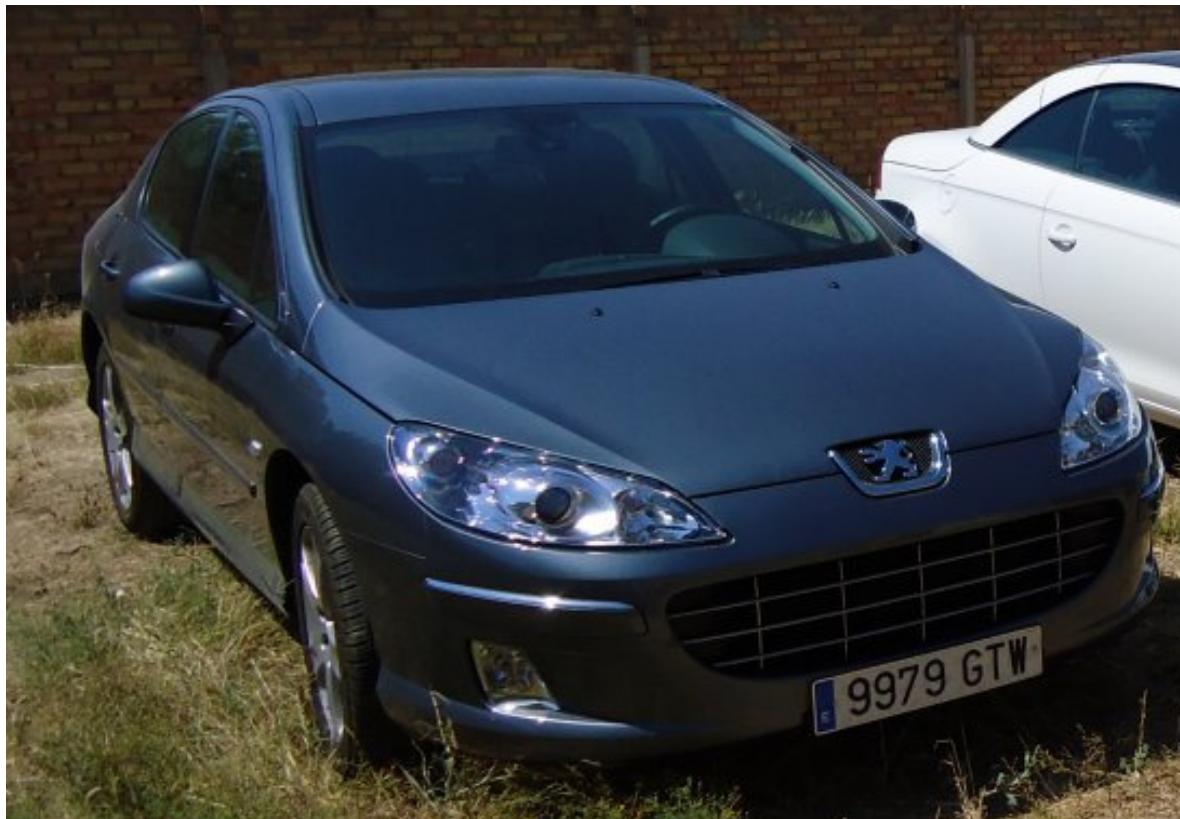
Figure 15: Peugeot 407 Coupé

Peugeot 407 Coupé

Year of manufacture: 2009

Angle backlight: 65,5° to vertical

Glass thickness: 3,85mm

Light transmission: 71% ±1,5%
