Product Parts of Copper alloy

Part Name	Thermostat
Part weight	80g
Copper Alloy Component weight	10g
Content % of Lead	1.8-3.7

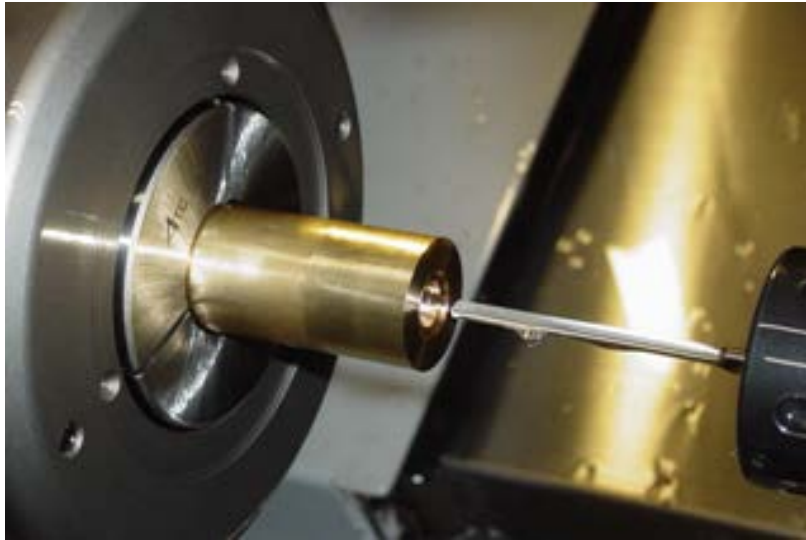
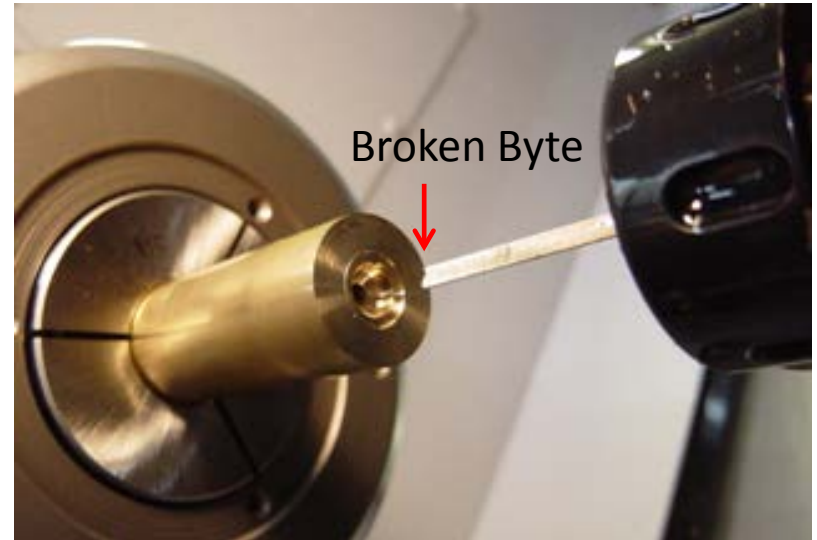
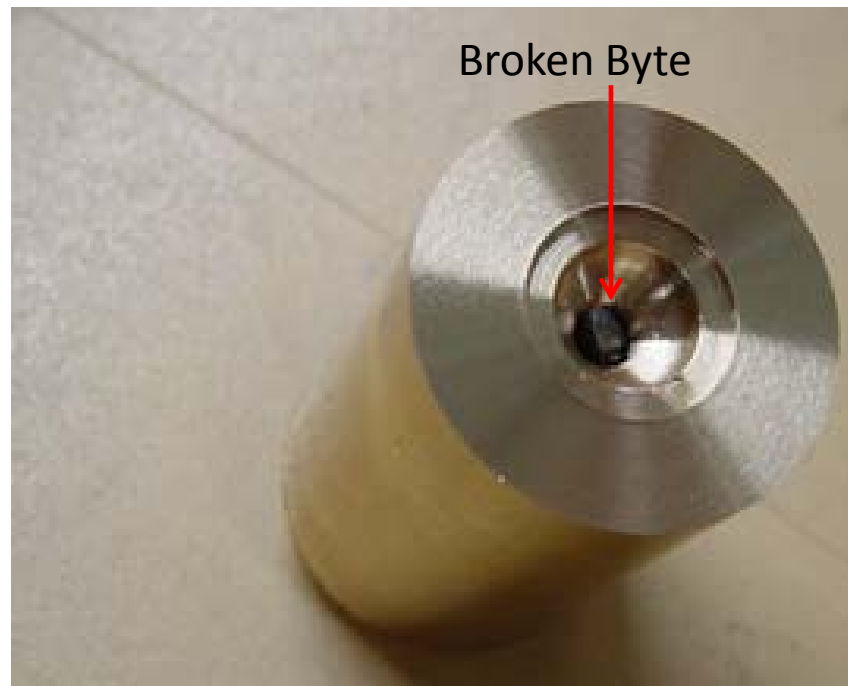
Broken Byte

φ3 drilling that only C3604 (3.2%) was possible. Byte breakage the others because the curly sawdust occurred.

Could not work because of occurring byte breakage at 2.2% alloy.

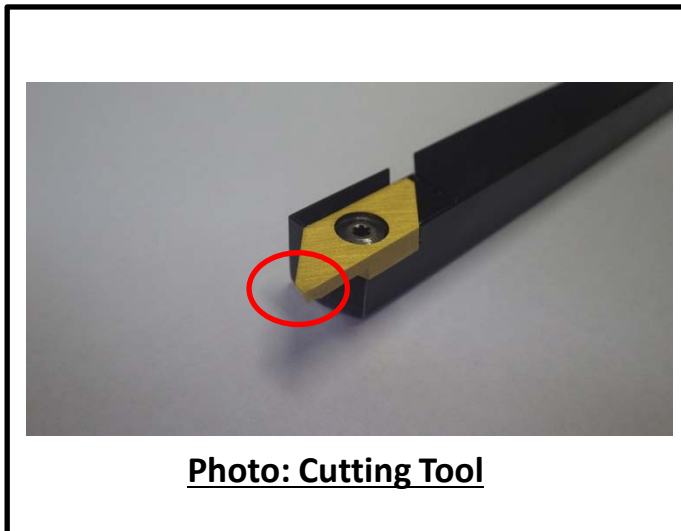
Photo: Cutting Tool

At some point during the Pb2.2%, 430 piece test, the cutting tool edge became chipped. No damage to the cutting tool tip was observed on the 3.07% Pb cutting tip until 25,000 pieces.
