# Indium Soldering on Glass

### Indium Soldering on Glass Test Results

Dr. M. Pinsker  
BMW, EK-430  
Page 12

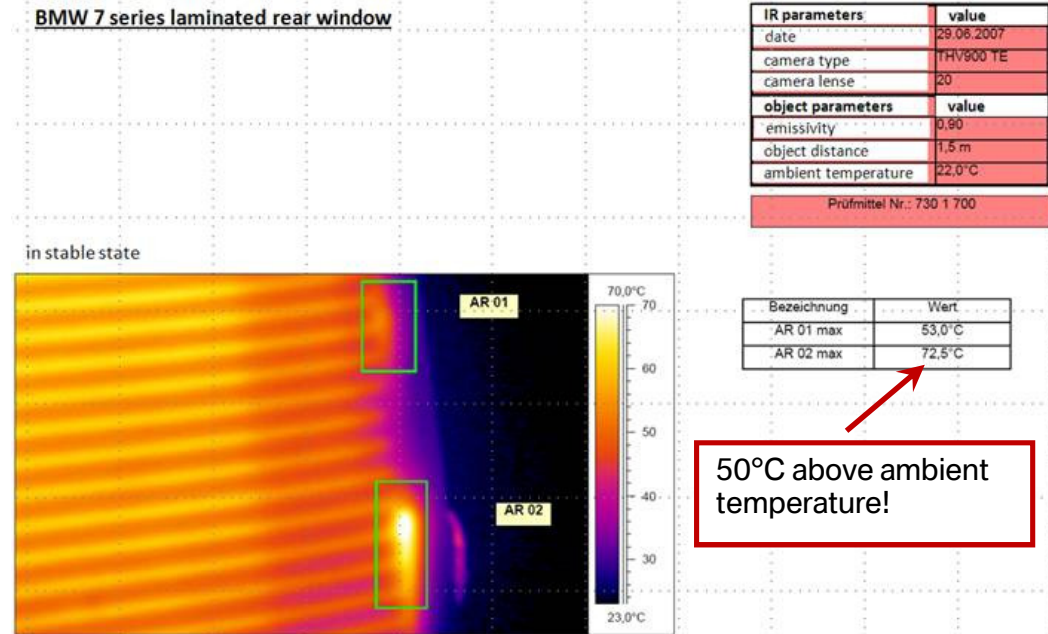
Taking into account operation of the heaters, which creates additional heat inside the connectors due to the electrical load, even higher temperatures than mentioned on the last slide will be reached. The humid air often leads to fog on the inner surfaces of the car. De-fogging of the rear

window, which is crucial for the clear outside view of the driver and is thus a safety-relevant function, is usually done using the heater.

Activation of the heater also heats up the connectors to up to 50°C above the surface temperature of the glazing, which may reach 70 .. 80°C under real-life conditions in a very humid environment.

Hence, when the heater is activated in a humid environment for de-fogging of the rear window, the temperatures reached will by far exceed 110°C which are known to cause Antaya's solder alloy to fail.
